# Manhole Inspection Summary

Manhole # S33S\_\_015MH

Insp Date: **2/5/08 3:43 PM**

**Location** Address: **race st**

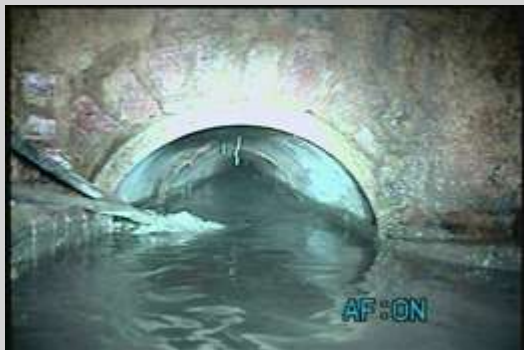
12 O'Clock Outflow

18 in. Circular Gravity Sewer  
Pipe Out @ 12 O'Clock

Pipe Material: **Clay** ☐ Pipe Lined

Invert Depth: **12.00** (ft.) Flow Characteristics: **Fast**

Deposits: ☒ None ☐ Mud ☐ Sludge ☐ Debris ☐ Grease

Infiltration: **None** Pipe Seal Cond: **Unknown**

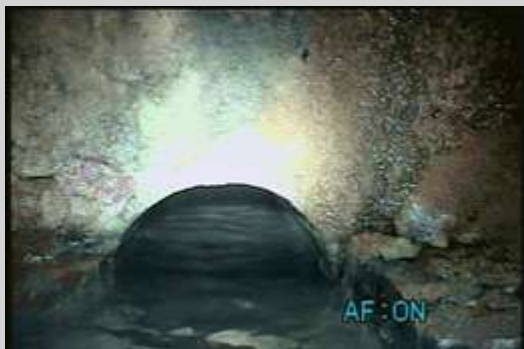
3 O'Clock Inflow

15 in. Circular Gravity Sewer  
Pipe In @ 3 O'Clock

Pipe Material: **Clay** ☐ Pipe Lined

Invert Depth: **11.80** (ft.) Flow Characteristics: **Fast**

Deposits: ☒ None ☐ Mud ☐ Sludge ☐ Debris ☐ Grease

Infiltration: **None** Pipe Seal Cond: **Unknown**

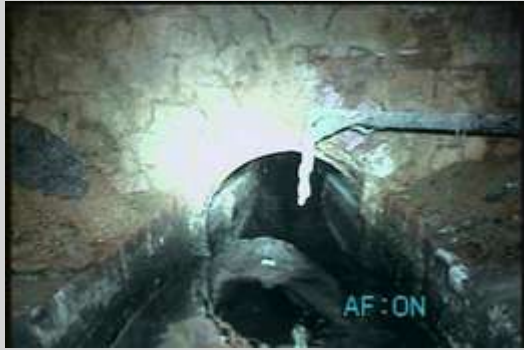
6 O'Clock Inflow

15 in. Circular Gravity Sewer  
Pipe In @ 6 O'Clock

Pipe Material: **Clay** ☐ Pipe Lined

Infiltration: **None** Pipe Seal Cond: **Unknown**
